Manhole Inspection Summary

Manhole # S37E__058MH

Location Address: **501 e fayette st**

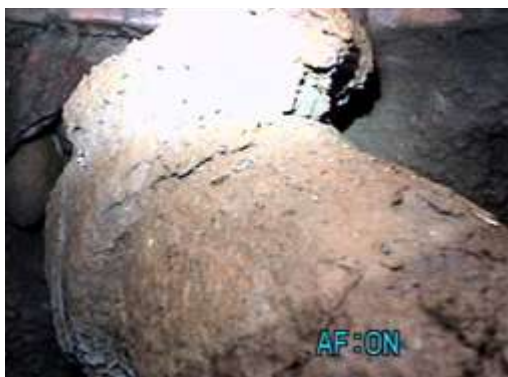
unknown pipe

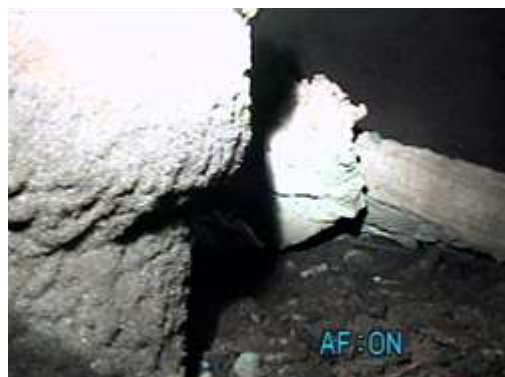
Pipe into ground

Not a inside drop it goes into the ground

Pipe goes into the ground

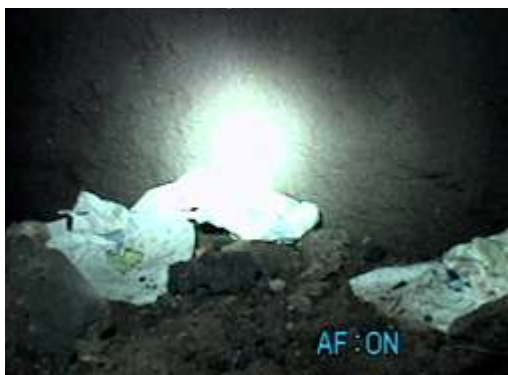
Defect 3

Condition: ☐ Sound ☐ Cracked ☐ Root Intrusion ☐ Deteriorated ☐ Leaks ☒ **Debris**

channel debris

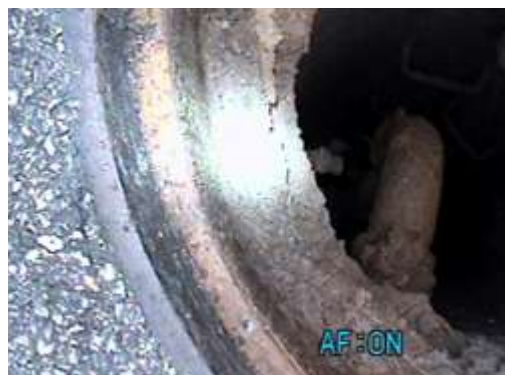
Defect 2

Offset: **4** (in.)

offset

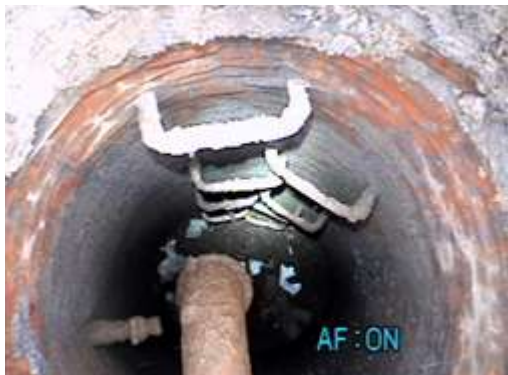
Defect 1

Count: **8** Missing: **0** ☒ **Corroded**

cor. steps

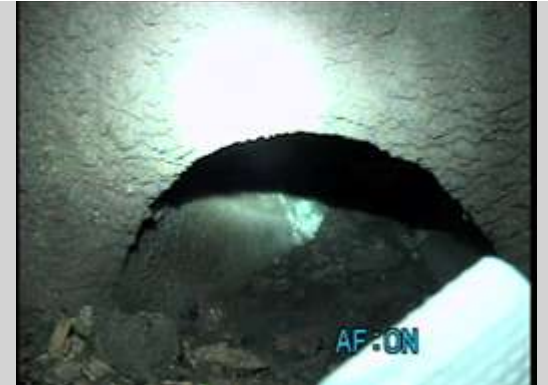
12 O'Clock Outflow

10 in. Circular Gravity Sewer
Pipe Out @ 12 O'Clock

Pipe Material: **Clay** ☐ Pipe Lined

Invert Depth: **12.80** (ft.) Flow Characteristics: **None**

Deposits: ☒ None ☐ Mud ☐ Sludge ☐ Debris ☐ Grease

Infiltration: **None** Pipe Seal Cond: **Unknown**
